**PLANNING MALAYSIA:**

**VOLUME 23 ISSUE 5 (2025), Page 398 – 412**

## **DIAGNOSING TIMBER DEFECTS IN TRADITIONAL MALAY HOUSE: A CASE STUDY OF RUMAH KUTAI KAMPUNG SELAT**

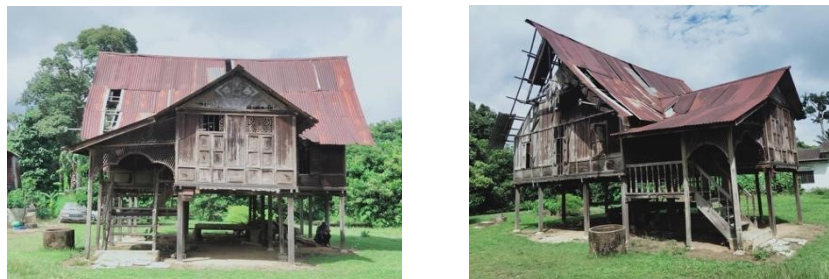
**Figure 2:** Front and side elevation of Rumah Kutai Kampung Selat

The structure of RKKS, such as columns and walls, was originally built using the Cengal timber. The floorboard used Balau and Meranti Merah timber. Meanwhile, Kempas timber was used for roof trusses. This house was built with several main basic spaces such as foyer space, porch space, motherhouse, interval house, and kitchen.

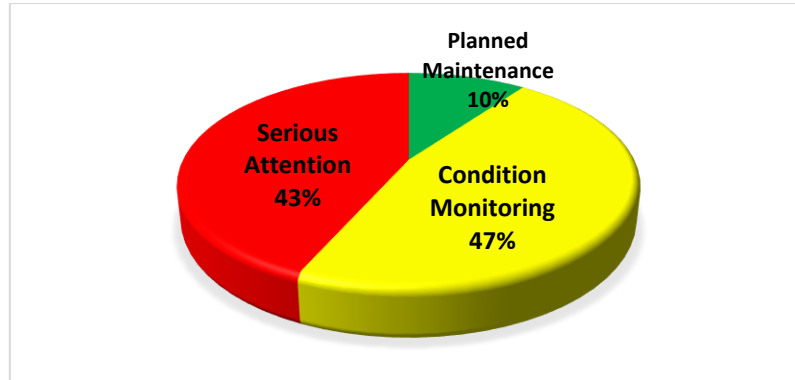
**Figure 3:** Defects Analysis by Matrix

The majority of the defects occurred under condition monitoring (47%). These defects need to be constantly monitored before they become major defects. The second highest is defects categorised as serious attention and needs urgent actions (43%). The defects under planned maintenance classification are the least defective matrix (10%), and they did not harm the occupants.

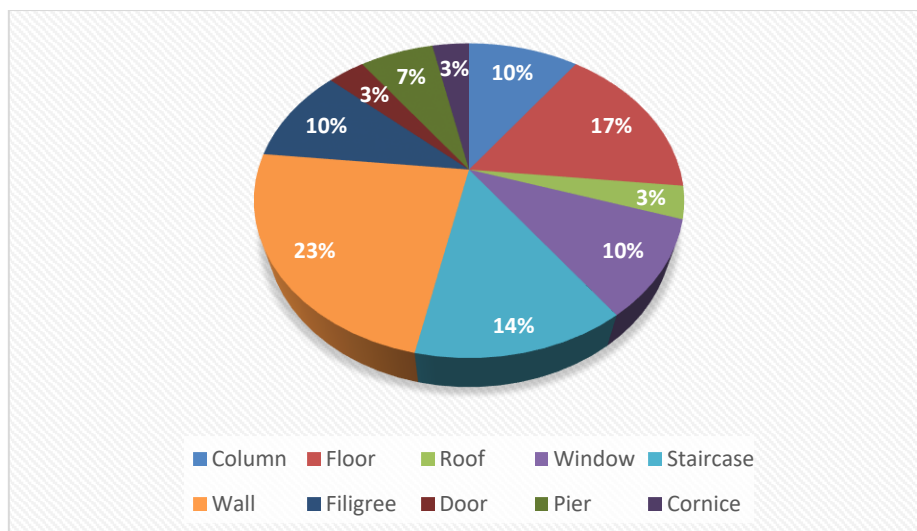
**Figure 4:** Defects Analysis by Elements

It is found that the wall is the most defective element (23%), followed by floor (17%), staircase (14%), and Others, i.e, window, filigree, and columns (10%). The least defective elements are the roof, door, and cornice, which represent 3% of the defects. Nur Fadhilah et al. (2022) stated that the wall is the most defective timber element in traditional houses. This will be dangerous to the occupants because it will decrease the timber building performance in terms of an aesthetic point of view.

The significant number of wall and floor defects observed in RKKS demonstrates the vulnerability of old timber structures to prolonged tropical exposure, particularly Malaysia's hot-humid climate with heavy rainfall and persistent moisture accumulation. Older Malay houses, particularly those over 70-100 years old, are naturally more vulnerable to biological agents and weather-driven deterioration, and this is in line with findings from traditional Malay buildings in Malacca (Nor Haniza et al. 2007) and Perak (M. Nurfaizal et al. 2020), wherein walls were likewise identified as the most defect-prone element. The findings confirm that climatic stressors and age-related stress remain the primary indicators of degradation trends in traditional timber buildings. Therefore, strengthening conservation practice for Rumah Kutai necessitates systematic preventive maintenance frameworks, rather than reactive repairs, to minimize moisture impact, prevent termite spread, and prolong the longevity of the original timber components.
