## **SYSTEMATIC INVENTORY FOR HERITAGE SHOPHOUSE FACADES IN IPOH, PERAK, MALAYSIA**

### **Abstract**

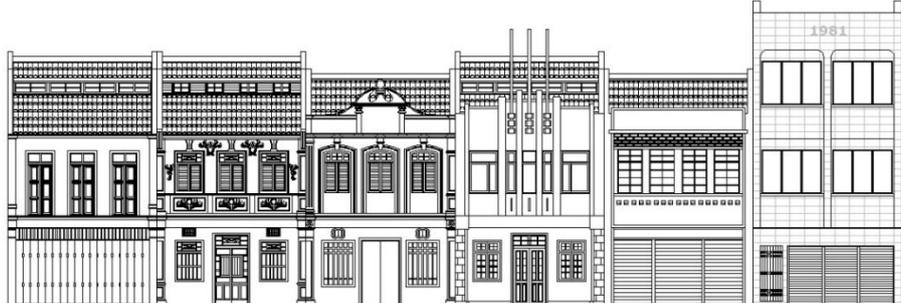
**Table 1:** Taxonomy matrix of architectural characteristics for heritage shophouse facades at Ipoh.

Transitional (1890-1900s)	Traditional (1890-1950s)		Neo-Classical (1880-1920s)	Art Deco (1925-1950s)	Modern (1940-1970s)	
Transitional		Traditional Eclectic			Neo-Classical	
<p>Used of timber for the upper floor beam. Engaged column at the upper façade and free-standing column below. Pitch roof with terracotta roof tiles. Wall is painted in pastel or white finishing. Some shophouses use timber wall at the upper floor. The door is two timber shutters, or vertical timber or metal folding panelling. Transoms light or fanlight infilled with glass, often combined timber carved or radiating bars. Two or three bay windows full-length shutters at the upper floor. Top part shutters has louvres, bottom part is a flat panel. Architrave framed the window openings sometimes with a keystone at the top. Some of the facades have full-width timber louvred shutters. Timber or steel lattice above door height along the wall at the ground floor for natural ventilation. Simple design with minimal ornamentation.</p>		<p>Used of timber for the upper floor beam. Engaged column at the upper façade and free-standing column below. Pitch roof with terracotta roof tiles. Bright colour painted on the wall. The door is two timber shutters, or vertical timber or metal folding panelling. Transoms light or fanlight infilled with glass are often combined timber carved. Two or three bay windows full-length shutters at the upper floor. Top part shutters has louvres, bottom part is a flat panel. Pilasters and architrave framed the window openings. Decorative plasterworks of flora motifs with various ethnic tradition influence.</p>			<p>Used of timber for the upper floor beam. Engaged column at the upper façade and free-standing column below. Cornice at the parapet, upper floor beam and column. Dentil below the beam cornice. Adaptation of Classical order such as fluted columns or pilasters. Pitch roof hidden behind parapet or a Grecian pediment. Wall is painted in pastel or white finishing. The door is vertical timber or metal folding panelling. Transoms light infilled with glass. Two or three bay windows full-length shutters at the upper floor. Top part shutters has louvres and sometimes infill with glass, bottom part is a flat panel. Architrave framed the window openings with a keystone at the top.</p>

<b>Art Deco</b>	<b>Modern</b>	
	<b>Early Modern</b>	<b>Modern</b>
Reinforce concrete beam. Engaged column at the upper façade and free-standing column below. Pitch roof with terracotta roof tiles sometimes hidden behind high pediment or parapet wall. Granulated render known as Shanghai plaster applied on wall. Door is timber or metal folding panelling. Metal frame windows infilled with glass. Concrete shading devices above the window frame. Concrete air vent slots at the upper floor facade. Windows are arranged in group typically three sets. Geometric design highlights straight lines or forms arranged either vertically or horizontally. Flagpoles and relief writing date of building construction on the facade.	Reinforce concrete beam. Engaged column at the upper façade and free-standing column below. Pitch roof with terracotta roof tiles sometimes hidden behind parapet wall. Painted in shade colour or white finishing. Door is metal folding panelling. Two or three bays windows, used of glass and steel framework and sometimes with glass louvres. Horizontal and vertical reinforced concrete shading fin. Various shape of concrete air vent slots at the upper floor. Relief writing date of building construction on the facade. Devoid any decoration and craftsmanship.	Reinforce concrete for the upper floor beam. Five-foot walkway sometimes built without columns. Some building exceeds two storeys height. Flat roof is hidden behind the parapet wall. Common used of wall tiles. Metal folding panelling door for ground floor access and single-leaf door for upper floor access. Large glass window with steel frame. Front façade usually built without vent hole. Windows are arranged in group. Geometric design in cuboidal form. Devoid any decoration and craftsmanship.

The relevant characters or parameters were finalised using thematic analysis: beam, column, roof, wall, door, window, air vent, fenestration and ornamentation to form a taxonomy of architectural styles (See Table 1). Secondly, the inventory form named ‘eFakad’ was developed with a specific mathematical formula to give the total value for each selection of architectural criteria. A pilot test for eFakad was then conducted. Thirdly, after a few improvements, fieldwork involving 65 shophouse facades (see Table 2) at Jalan Sultan Iskandar, Ipoh which represent a sample size of approximately 6.4% of the population (the total number of heritages shophouses at Ipoh is 1,022) was conducted. Finally, an analysis and report were prepared to complete this research paper.
