**PLANNING MALAYSIA:**

**VOLUME 23 ISSUE 5 (2025), Page 499 – 511**

## **EVALUATING KELARAI ASLI IN HERITAGE CONSERVATION AS A CULTURAL ASSET OR CONSTRAINT**

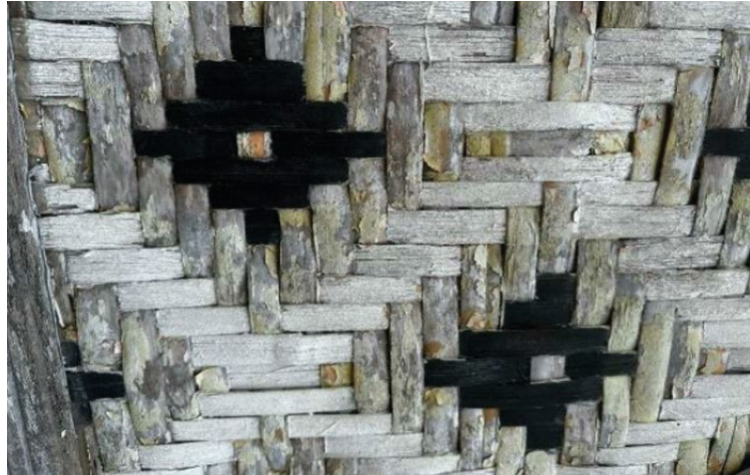
One of the defining features that has caught public attention is the mosque's distinctive usage of Kelarai asli that is a traditional bamboo weaving technique on its external walls. This decorative element is now rare and visually striking, reflecting local artisanal knowledge, vernacular building practices, and Malay aesthetic values. Such craftsmanship is increasingly endangered, and its preservation aligns with the department's mission to safeguard indigenous heritage expressions. Unfortunately, the current condition of its Kelarai asli (as shown in Figure 1.0) has drastically deteriorated.

**Figure 1.0:** Current condition of the Kelarai walls of Ihsaniah Iskandariah Mosque, Padang Rengas  
(Source: Syed Mustapa et al., 2024)

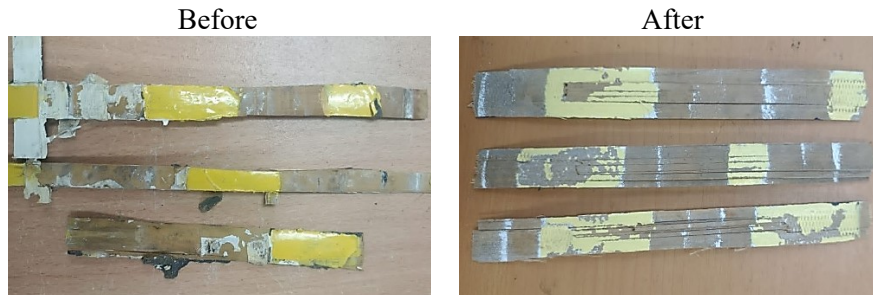
**Figure 3.0:** Before and After ASTM D3039 Testing

Shown in Figure 3.0, before testing, the Kelarai asli strips appeared relatively undistorted and intact. After the tensile test, the specimens displayed visible elongation and tearing patterns along the fibers, confirming that axial tensile force had been applied. While the bamboo strips remained largely intact, some fraying at the ends and surface cracking are observed—consistent with expected tensile failure in natural materials. The fiber alignment remained clearly visible, illustrating the direction of stress application and showcasing the woven structure's capacity to distribute tensile forces.

The tensile test, conducted in accordance with ASTM D3039, is designed to assess the tensile properties of materials, particularly their ability to resist axial loading until the point of failure. This test is essential in evaluating the mechanical performance of materials used in heritage conservation, especially those subject to environmental stressors. The material is tested under controlled load until failure to simulate its durability and structural reliability when used in architectural applications (ASTM International, 2017). For this study, natural kelarai asli panels are subjected to tensile loading to simulate real-life conditions where such materials would experience stress in structural applications. The results demonstrated notable tensile strength values, with Sample 1 recording a maximum load of 2.1 kN and Sample 2 recording 1.6 kN. These findings suggest that natural kelarai possesses considerable resistance to stretching forces before rupture.

The findings indicate that Kelarai Asli possesses significant structural integrity and is a promising candidate for use in heritage restoration projects where strength and durability are critical. Its ability to withstand considerable mechanical stress suggests that it can be efficiently applied in structural components that must endure environmental loads or other external factors commonly affecting cultural monuments. Its strength ensures that it can maintain its functional integrity over time, provided it is properly preserved. The fibrous texture of the kelarai, combined with the traditional weaving technique, contributes to a mechanically robust material capable of withstanding considerable stress.

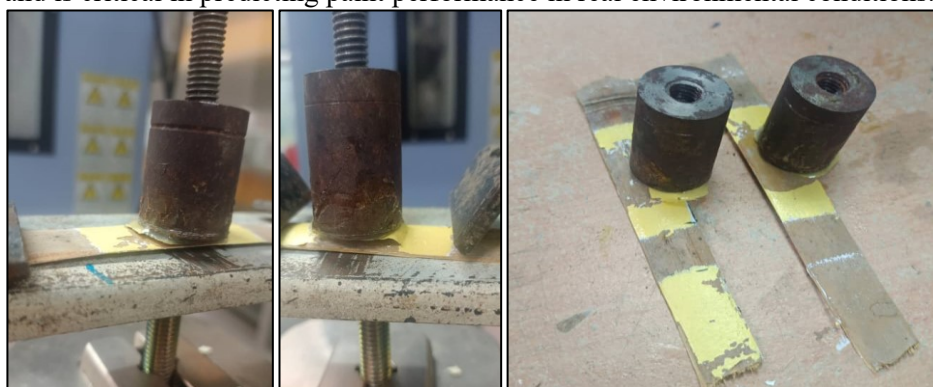
The ASTM D4541 test is then employed to assess the adhesion strength of paint applied to the material surface. This test measures the pull-off strength required to detach a coating (e.g., paint) from its substrate (e.g., kelarai) shown in Figure 4.0. It helps to assess the durability and bonding quality of coatings under stress and is critical in predicting paint performance in real environmental conditions.

**Figure 4.0:** Adhesion Test Images

Table 2.0 displays the pull-off test results that show both Sample 1 and Sample 2 experienced 100% adhesive failure, indicating that the failure occurred entirely at the interface between the adhesive and the Kelarai Asli surface. No cohesive failure within the substrate or adhesive layer is detected. Sample 2 exhibits a significantly higher pull-off force (48.43 N) compared to Sample 1 (14.06 N), suggesting better adhesive strength. However, the consistent occurrence of adhesive failure across both samples highlights a potential weakness in the bonding interface, possibly due to inadequate surface preparation or incompatibility between the adhesive and the Kelarai Asli material.

With regards Paint Adhesion Kelarai Asli passes the test of maintaining a robust bond with surface coatings, suggesting that it is compatible with modern restoration practices. Despite a minor failure rate (10%), this result confirms the material's utility for aesthetic and protective finishes in heritage conservation. The adhesion strength is especially important for retaining the visual appeal and protecting the material from environmental damage, such as weathering or UV.
