## **CONDITION ASSESMENT STUDY OF ROAD DEFECTS IN MERSING DISTRICT ROAD IN JOHOR**

This study covers road distress that is further discussed as flexible pavement distress. Road condition is crucial for safety and is also used to forecast maintenance schedules. The objectives of this study are focused on determining the road defects and identifying the conditions of the road defects in Mersing district. The method used in this study was based on observations made on the road referring to ASTM D6433 and Technical Manual, Pavement Maintenance Management which according to the Public Work Department (PWD) standard. This research concentrates on two selected roads in the Mersing district which are (i) Tanjung Resang Road and (ii) Tanjung Resang - Penyabong Road. For data collection, mixed methods such as observations (picture) and calculation of Pavement Condition Index (PCI) is used. The findings indicated that the road condition in these two Mersing roads requires more regular maintenance. The results show that the lowest priority roads require better maintenance planning and consistent implementation, as well as re-planning of maintenance structure. Overall, this study contributes n

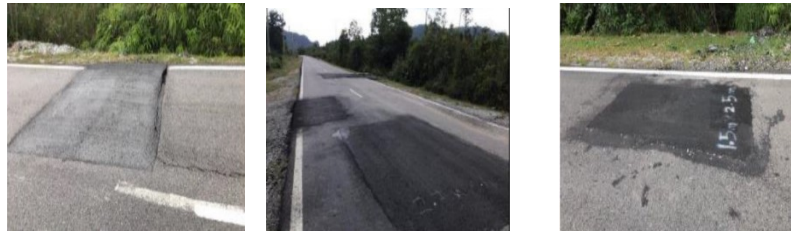
**Figure 6:** Patching on Tanjung Resang Road

Figure 6 indicates that there are patches on the Tanjung Resang Road samples of plate a, plate b and plate c, respectively. The patches on the road have the quantity of 0.40 m<sup>2</sup>, 1.15 m<sup>2</sup> and 2.88 m<sup>2</sup>.

Table 1 shows the density percentage for patching in TR roads are 0.08%, 0.23%, and 0.58% for road samples 1, 2 and 3. Furthermore, 0.23% is the density percentage for both sample 4 and 5 of alligator cracking. The third road defect is polished aggregate, which is 0.23% for sample 6, 0.26% for sample 7 and 0.08% for sample 8. The last road distress is longitudinal cracking with a density of 0.02%.

The purpose of determining the severity and density percentage is to find a DV for each of the road distress. Each distress has a different distress DV curve. For patching, based on Table 2, the DV for low severity with the density of 0.08% is 0. Medium severity patching with 0.23% density has a deduct value of 3. Then, high severity patching with 0.58% density has the deduct value of 14. Next, both alligators cracking with medium severity in TR road density 0.23% have the deduct value of 14. Then, the polished aggregate deducts value curve (Appendix A) recorded the deduct value of 0 for the density of 0.23%, 0.26%, and 0.08%. Lastly, the low severity longitudinal cracking with the density of 0.02% gains the deduct value of 4.

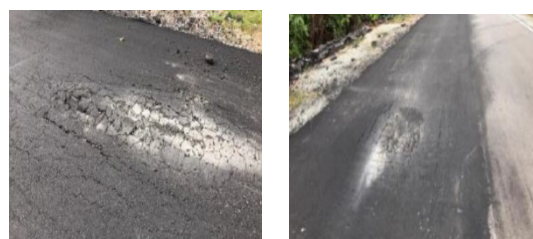
**Figure 8:** Alligator Cracking on Tanjung Resang Road

Figure 8 shows that the surface area of alligator cracking is measured in meter square. Alligator cracking was identified in TRR samples. 1.15 m<sup>2</sup> are the sizes for both road segments that encountered alligator cracking.

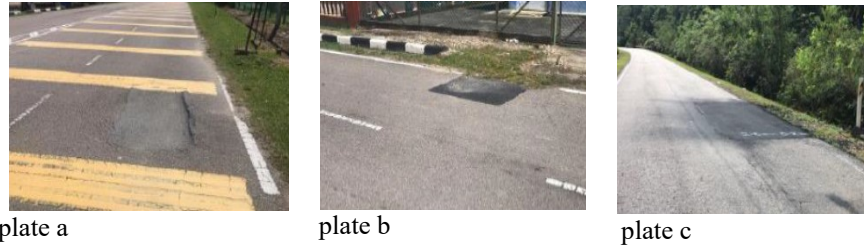
**Figure 12:** Patches on TRP Road (Source: Researcher's Observation)

The visual observation made from TRP road discovered that there are two patches on the road segments Figure 12. The area of the patch's defects found are 2.63 m<sup>2</sup> and 1.50 m<sup>2</sup> the last defect found on Tanjung Resang – Penyabong road are categorized as raveling. Figure 15 shows road segment nine which has a raveling at 1.76m<sup>2</sup>

Based on Table 4, it can be found that the defects that occur are those of number 13 (polished aggregate), 6 (patching), 14 (longitudinal cracking) and 17 (ravelling) for TRP road. Next, the patching for TRP roads is low and high severity. The low severity shows that the patch in sample 5 is in good working order and delivers satisfactory results. Lastly, the TRP road has a high degree of distress severity recorded and this is when the patches must be replaced.
