**PLANNING MALAYSIA:**

**VOLUME 24 ISSUE 4 (2026), Page 864 – 878**

## **THE KHATABA VENTILATION METHOD: ENHANCING FOUNDATION DURABILITY IN KHIVA'S ARCHITECTURAL MONUMENTS**

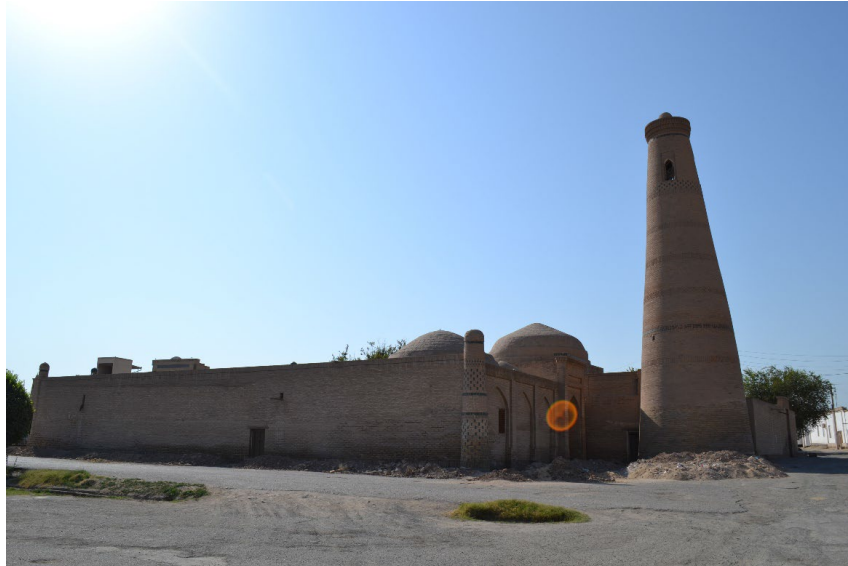
**Figure 3:** General view of the Bikajon Bika madrasa from the north-east.

The Bikajon Biki madrasa and minaret, restored in 1894 and located in Deshon Qala, showed visible dampness and salt-related brick damage in the lower wall and plinth zones. The general view of the Bikajon Biki madrasa from the north-east is shown in Figure 3. In this monument, two Khataba variants were used depending on the local structural and environmental conditions. A trench 50-60 cm wide was dug along the wall, and baked brick was laid opposite the monument wall while maintaining a ventilated gap of about 25-30 cm from the foundation. The trench-type Khataba system applied to the eastern wall of the Bikajon Biki madrasa is illustrated in Figure 4. On the northern facade, which faced the roadway, the ventilation shaft was filled with rubble stone to improve resistance to dynamic vibration caused by heavy traffic. The ventilation shaft in the northern wall, filled with rubble stone for added stability, is shown in Figure 5. Restoration views of the northern facade, including pre- and post-intervention details, are presented in Figure 6. Application of the trench-type Khataba system on the northern and northeastern walls is depicted in Figure 7.

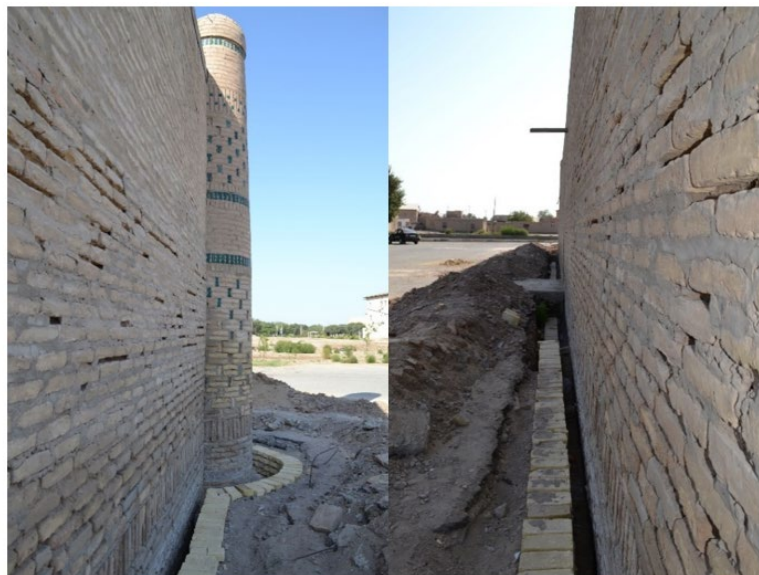
**Figure 4:** Application of the trench-type Khataba system on the eastern wall of the Bikajon Bika madrasa.

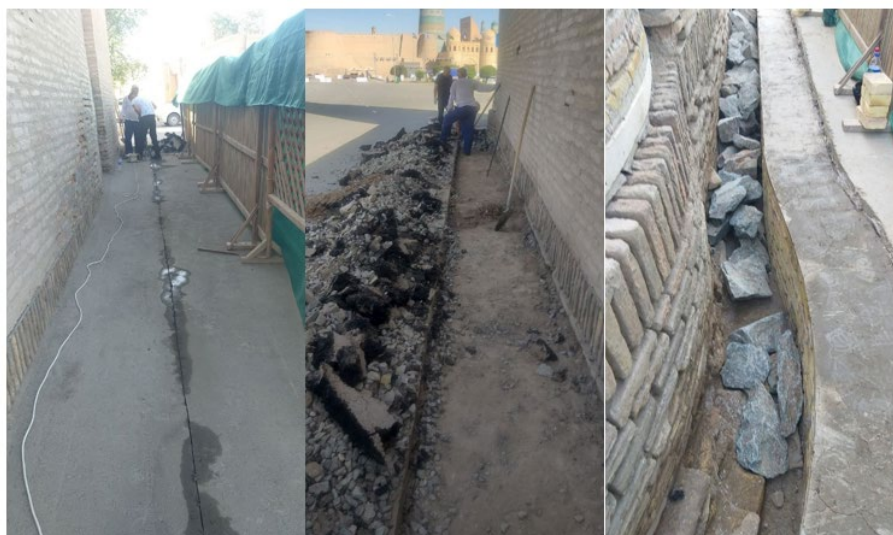
**Figure 6:** Northern facade of the Bikajon Bika madrasa and related restoration views.

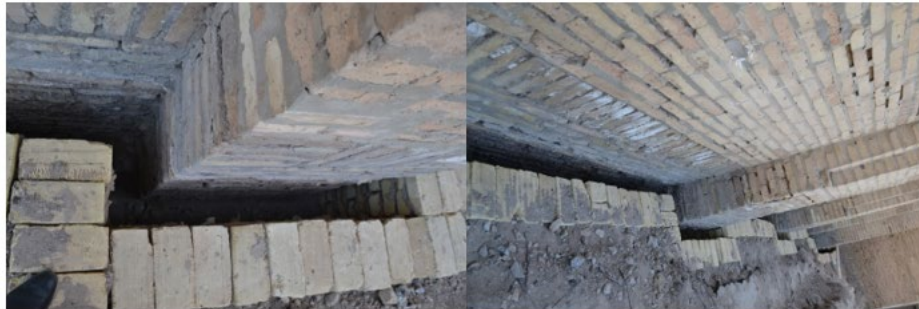
**Figure 7:** Application of the trench-type Khataba system on the northern and northeastern walls of the Bikajon Bika madrasa.
