PLANNING MALAYSIA:
Journal of the Malaysian Institute of Planners
VOLUME 18 ISSUE 2 (2020), Page 1 – 11

ASSESSMENT OF THE HISTORIC INTERIOR OF CARCOSA HERITAGE BUILDING, KUALA LUMPUR FOR BUILDING CONSERVATION

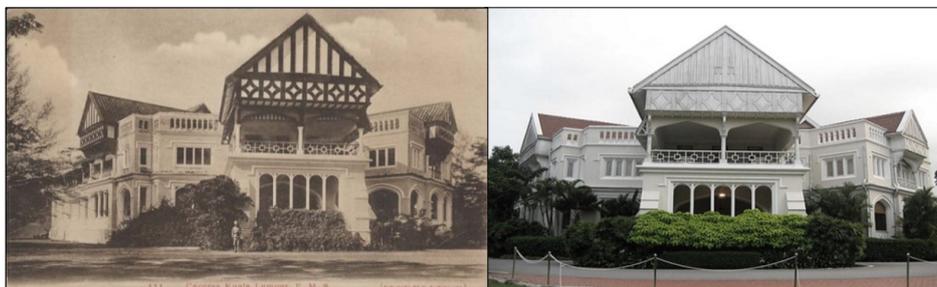
Figure 1: Carcosa in year 1900 (left) and the building in 2018 (right), still remain the original form and design, however the decorative timber at front gable has been painted and covered the Tudor features.

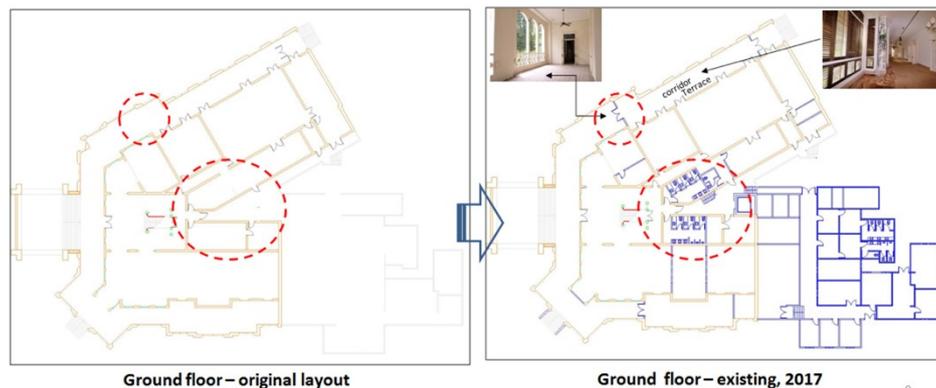
Figure 3: Corridor terrace (A) has been closed for part of expansion of hotel suite room. New toilets and refreshment room (B) has been added behind the main staircase.
Source: Harun (2018)

In 1989, during Queen Elizabeth's II visit, she occupied Swettenham's spacious suite rooms, which had been redecorated in the Victorian style (Warren & Gocher, 2007). In the year 1997, the mansion was renovated again, acquiring a spa, satellite TV, and upgraded kitchen while preserving the original appearance of the building (Warren & Gocher, 2007). Besides the interior preservation, to meet the hotel requirement, especially the number of rooms and facilities, part of the corridor and terrace at the ground and the first floor was closed for new rooms and toilets (Figure 3 and 4).

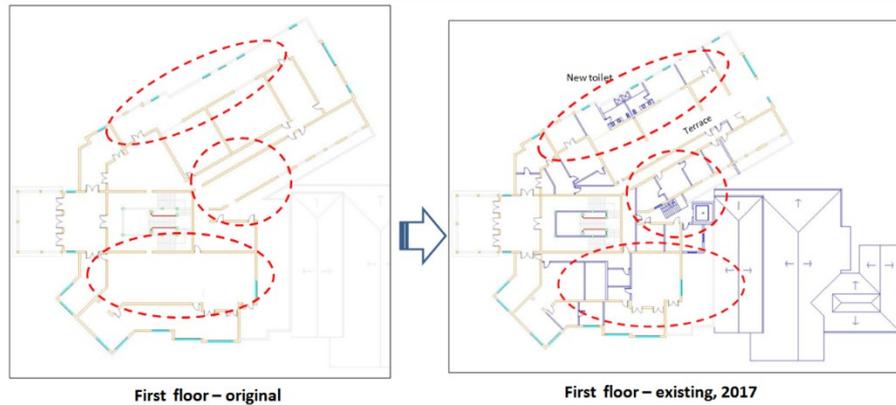
Figure 4: Corridor and terrace at first floor (A and B) closed for new rooms and toilets. The main hall (C) been renovated as hotel suite room.
Source: Harun (2018)

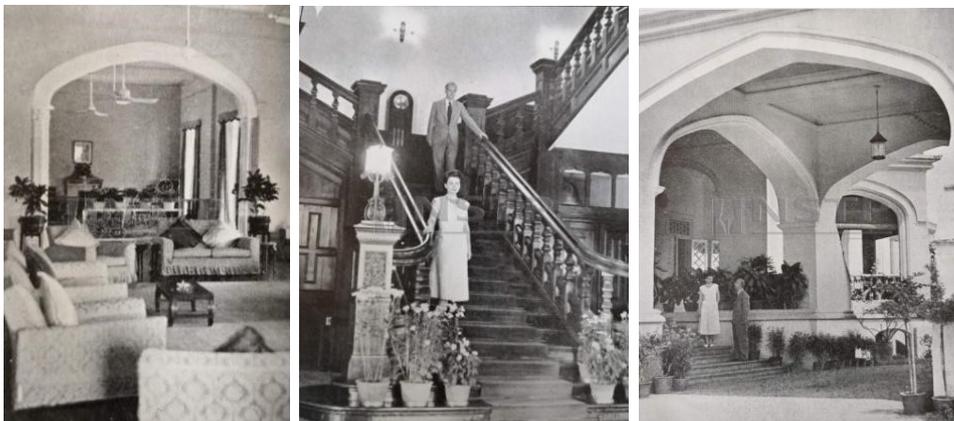
Figure 5: Carcosa during British Resident. The historical photos captured this historic moment of the mansion; (a) The spacious rooms were lavishly furnished, (b) The grand staircase, and (c) Carcosa's spacious porch.

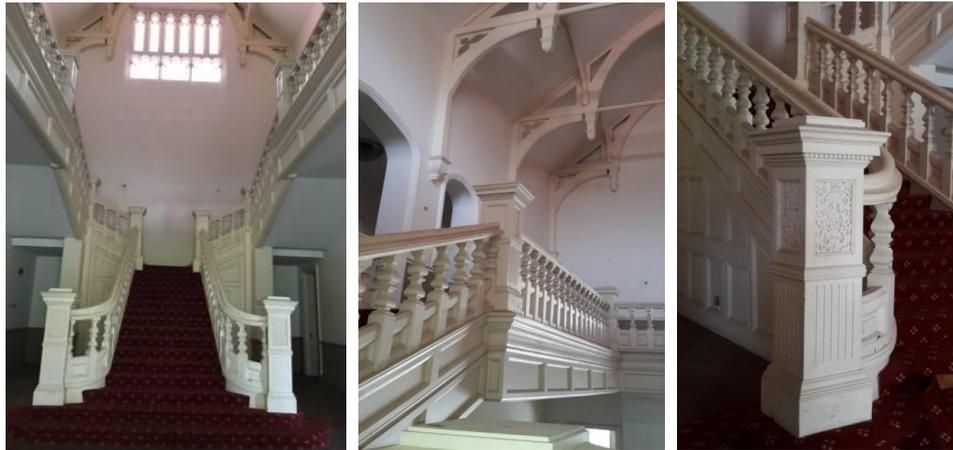
Figure 6: The existing timber staircase. All components, including the railing, balustrade, and decorative elements had been painted in cream thick paint.
