**VOLUME 23 ISSUE 4 (2025), Page 522 – 537**

## **QUANTIFYING EMBODIED CARBON EXPENDITURE IN GREEN MAINTENANCE OF HERITAGE BUILDINGS: A CASE STUDY OF MARSEILLE CLAY ROOF TILES REPAIR**

**Keywords:** Embodied carbon expenditure, Green Maintenance (GM), Marseille clay roof tiles, Life Cycle Assessment (LCA), Environmental Maintenance Impact (EMI), low-carbon repair

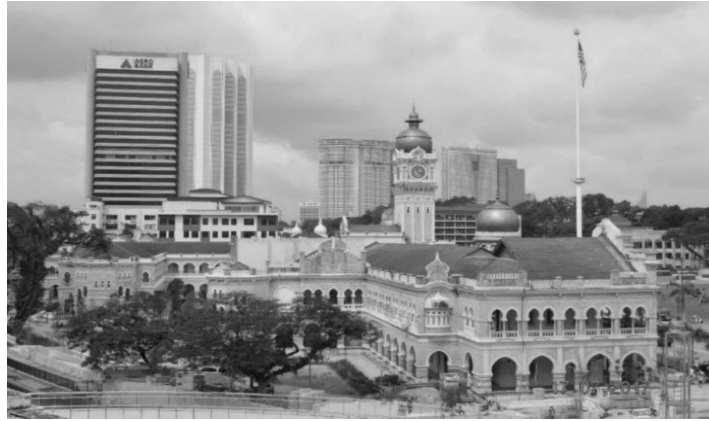
**Figure 3:** Bangunan Sultan Abdul Samad (case study)

Bangunan Sultan Abdul Samad (Figure 3) inherited late 19th-century Indo-Saracenic, Neo-Mughal and Moorish styles, elaborated with pitched-Marseille clay roof tiles. The building was declared a National Heritage on 24 December 2008, under the National Heritage Act (Act 645) Malaysia, Section 67 (2)(a), i.e., a building with historical importance, association with or relationship to Malaysian history (Malaysia, 2006). The building's background and technical specifications for the Marseille roof tiles and common defects are described in Table 1. In 2019, a major repair was undertaken to the damaged roofing structure and covering materials using locally sourced Marseille-Monier clay roof tiles. In the case of this paper, the defective or damaged Marseille-Monier clay roof tiles are replaced with identical specification and similar materials to attain their authenticity based on repair work procedures by Jabatan Warisan Negara, Malaysia (JWN).
